## Courtesy Safety Notice: AustriAlpin COBRA® buckles

Fulpmes, 14 January 2016

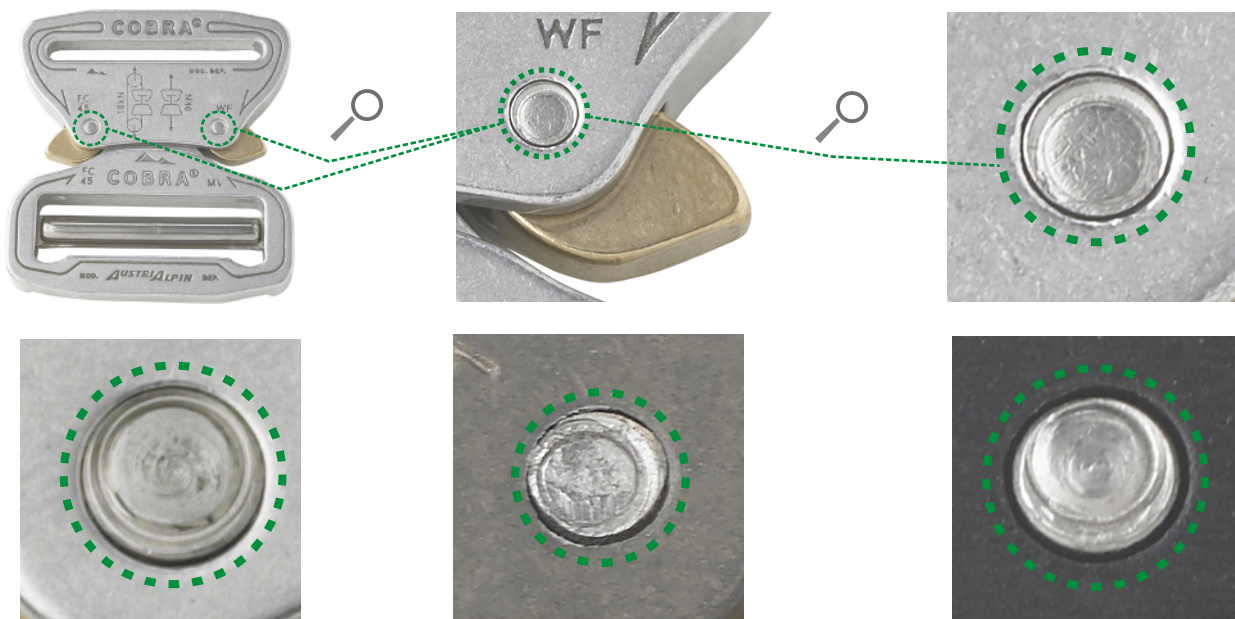
### Correct

The rivet shows an embossing in the form of a ring on both the front and back sides of the rivet. Do not manipulate the rivets by mechanical action.

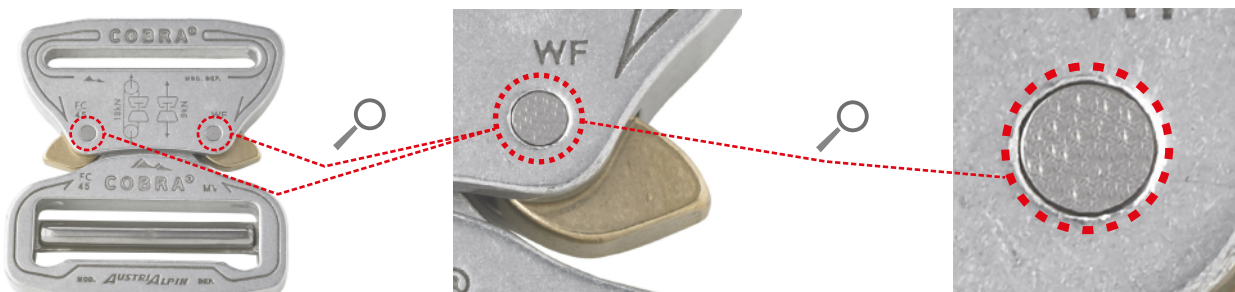
### NOT Correct

it has come to our attention that in an extremely small quantity ( $0.0000005\% = 1$  out of 2 million) of COBRA® buckles there may exist parts where the rivets have **not** been **press fixed**.

This results in the rivets being loose and the release clips detach. COBRA® buckles in all different versions and sizes can be affected. As we are dedicated to the 100% function, performance, quality and safety of our products, we ask all our clients and end users of COBRA® buckles to **do a visual check**:

The rivet does not show any circular embossing.

If you notice a buckle that is NOT riveted or you do have any concerns, STOP USING the product immediately and get in contact with us: [office@austrialpin.at](mailto:office@austrialpin.at) or via phone +43 522 56 52 48
