| <b>Product</b> | <b>Kontainer V4</b> |

# SAFETY NOTE

Problème sur le fourreau guide des élévateurs sur le Kontainer V4.

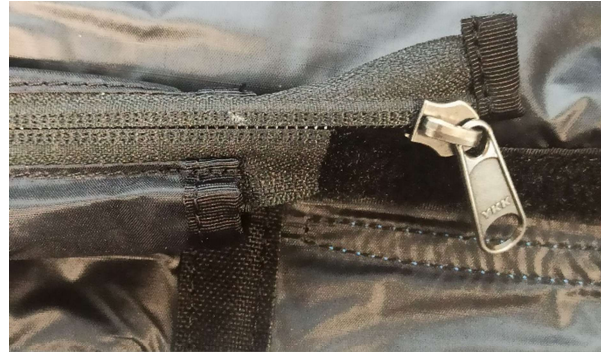
- Open the Kontainer V4 and view the central area where the sleeve is connected via Velcro.

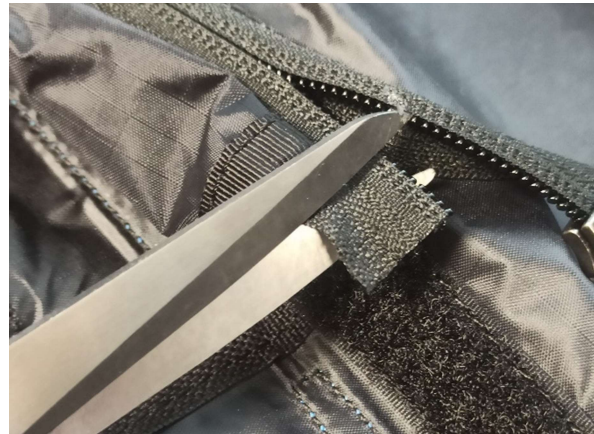
- Cut off the "short" part of the zip that protrudes from the sleeve with a scissor.

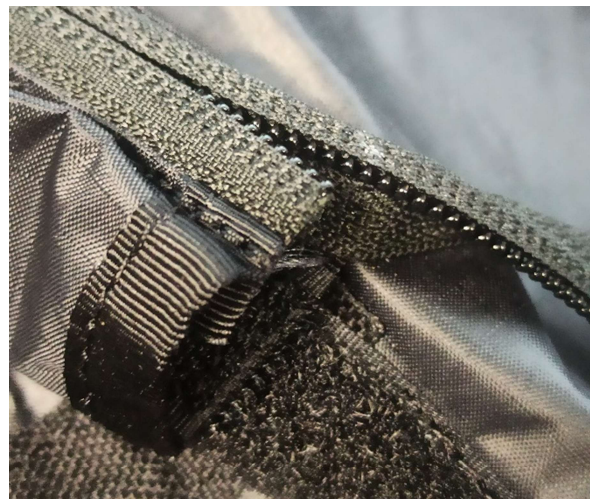
- Check that the zip is flush with the sleeve, and that the slider can remain in place on the other side when the zip is fully closed.
